37.0 ADVANCED ENGINEERED COATINGS WITH EXTENDED DIE LIFE FOR TOOLING

Nelson Delfino de Campos Neto (Mines)

37.1 Project Overview and Industrial Relevance

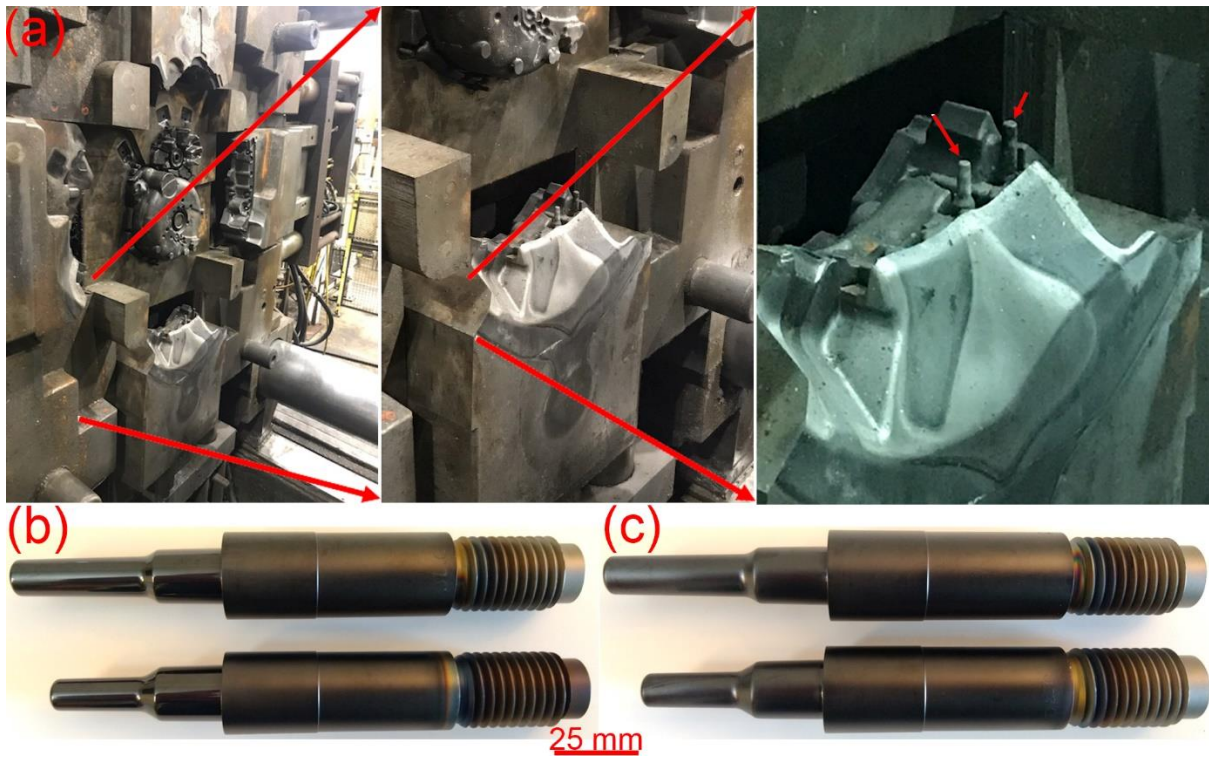
The industry die casting trial on coated core pins was performed at the Stellantis die casting plant in Kokomo, IN. As shown in **Figure 37.1**, these experiments involved core pins that experience severe conditions as they are located directly in-front of the gate in a die used to produce a large automotive casting. Since only the core pins were coated, this die run using conventional application of lubricant spray, and around 2,500 castings were produced using each set of coated core pins. Qualitative comparison and quantitative measurements were performed to identify the amount

Figure 37.1: (a) Images of the die used for the soldering trial at Stellantis. Detail for the two core pins (models 5205 and 5215) located in front of the gate that received different PVD coatings with two surface finishes: (b) diamond polishing and (c) draw finish.

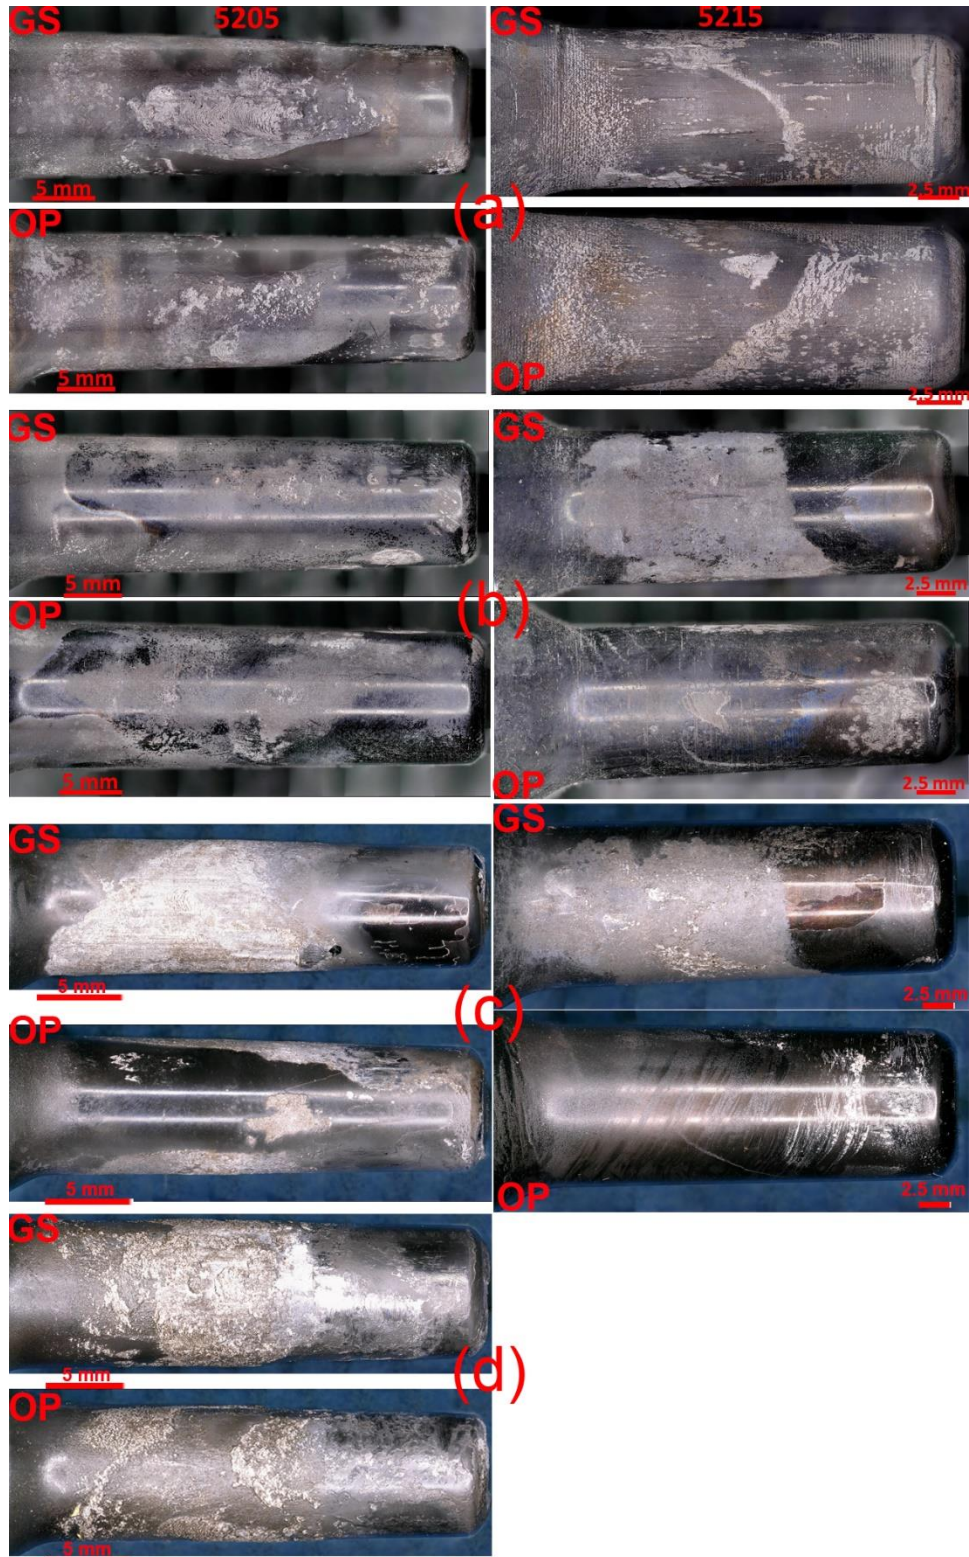
Figure 37.2 shows a more detailed 3D reconstruction of both sides of the cores acquired using a Keyence microscope for the nitrided-draw, Si-DLC-polished, AlCrN/TiCN-polished, and Al₂O₃-draw. Since the other core pins were destroyed during removal from the die, the 3D analysis of those cores were not possible. The nitrided-draw on **Figure 37.2(a)** shows similar distribution of soldering in the facing gate side (GS) and on the opposite gate side (OP), and brownish corrosion marks can also be seen in several areas. For the Si-DLC-polished on **Figure 37.2(b)**, core pin 5215 showed similar distribution of soldering in GS and OP, but core pin 5205 had a much more concentrated soldering in the GS side while a little more distributed on the OP side. Blue oxidation marks are present closer to the tip surrounded with some brownish corrosion marks. AlCrN/TiCN-polished coating on **Figure 37.2(c)** shows a more concentrated soldering on the GS side, and the OP for 5205 presented a small concentration of soldering in the center and border, while OP for 5215 had more dispersed soldering through its length, concentrated closer to the pin tip and inclined radial areas along its length. Different surface heights can be inferred from these images, showing what seems to indicate that the coating has been partially removed in several areas of the core pin, with more occurrences closer to the tip. Al₂O₃-draw coating on **Figure 37.2(d)** showed concentrated gross soldering in the center of GS and several spots of gross soldering in the same area in the OP. Gross soldering was more continuous in the GS than it was in the OP side.

Figure 37.2: Optical 3D reconstruction for both sides of the surface of the tested core pins models 5205 and 5215, where: (a) nitride-draw, (b) Si-DLC-polished, (c) AlCrN/TiCN-polished, and (d) Al₂O₃-draw.

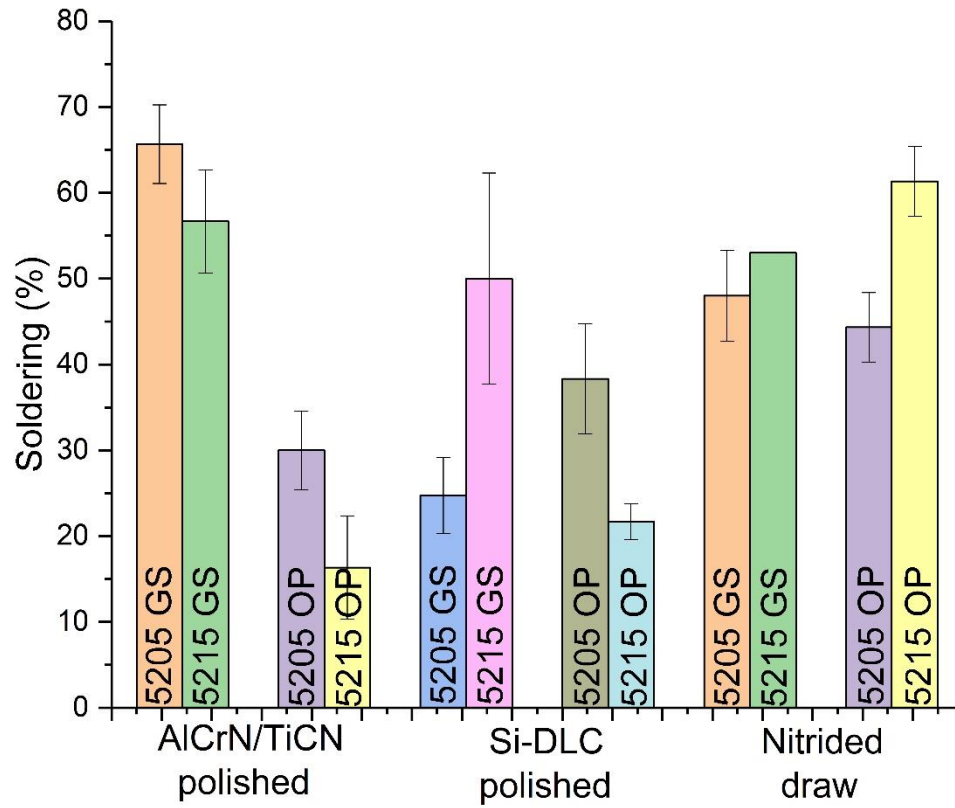
By using image analysis in the Keyence software, these images were used for the quantification of the percentage of surface area covered with aluminum for the GS and OP, and these results are also shown in **Table 37.1**. **Figure 37.3** shows a comparison between soldering on core pins 5205 and 5215 for the same side (GS vs GS and OP vs OP) with the same coating and finish for direct comparison of which core pins suffered more soldering. The same number of occurrences were found for each core pin, but some differences were found for each coating. The AlCrN/TiCN-polished presented more soldering on the 5205 core pin in both sides, while for the nitrided-draw had more soldering on the 5215. The Si-DLC presented more soldering on the GS of 5215, but the opposite for the 5205. Calculating the average soldering for 5205 results in $42 \pm 12 \%$, while for 5215 is $43 \pm 18 \%$. So no obvious trend could be found, but more variability of soldering could be seen for the 5215, meaning that this core pin can suffer more or less with soldering.

Figure 37.3: Soldering on different coatings comparing core pins models 5205 and 5215. GS = gate side, OP = opposite of gate side.

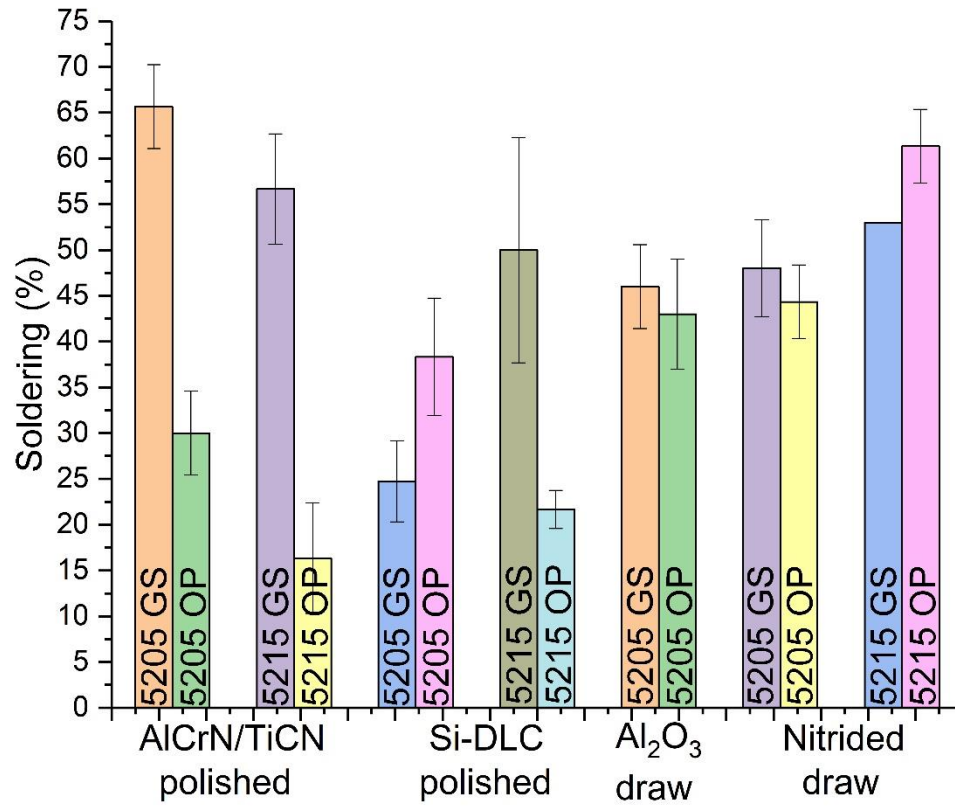
Figure 37.4 compares the soldering fraction on the GS vs OP for the same core pin. A higher number of occurrences were found for the GS (5) against the OP (2). The only two occurrences where the OP had more soldering were on core pin 5205 for the Si-DLC-polished and on the 5215 for the nitrided-draw, so no tendency based on core pin was found. But, a higher total fraction of surface covered with soldering was found for the core pin GS = $48 \pm 14 \%$ in comparison with the OP = $36 \pm 15 \%$ calculated for all coatings. For the GS, Si-DLC-polished coating showed the smallest amount of soldering for the 5205 pin, while for the OP the AlCrN/TiCN-polished coating had the smallest fraction of soldering on the 5215 pin.

Figure 37.4: Soldering on different coatings comparing GS an OP sides for core pins models 5205 and 5215. GS = gate side, OP = opposite of gate side.

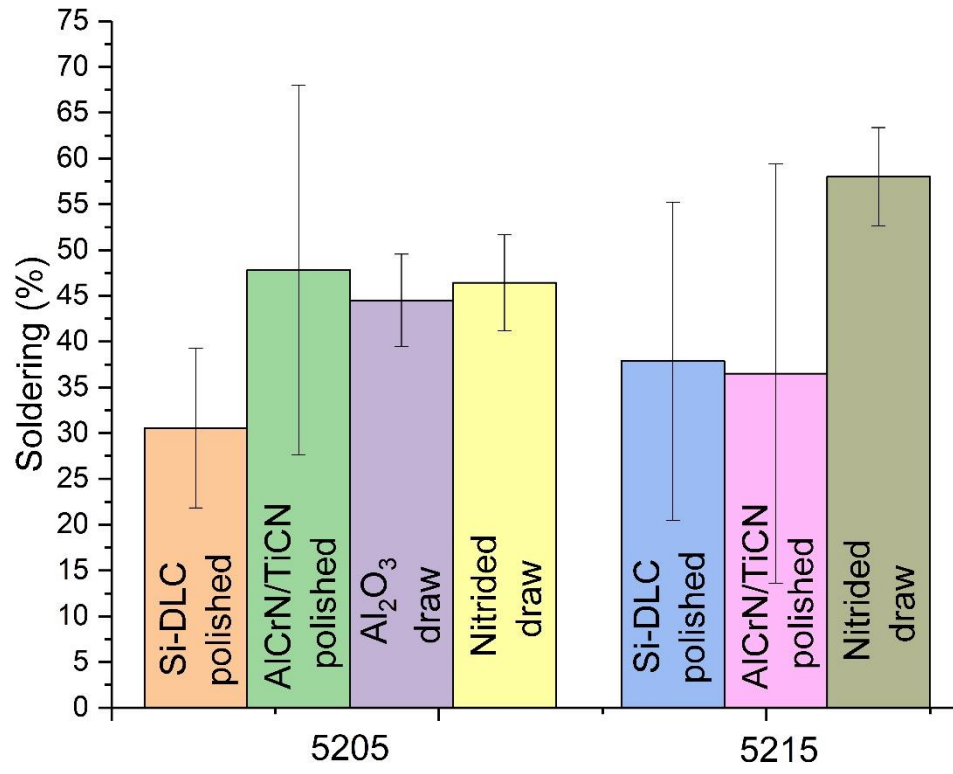
Figure 37.5 compares the average of soldering for the different coatings. All the coatings had less soldering than the uncoated H13 with only a nitriding treatment. The Si-DLC-polished presented the least amount of soldering within the tested coatings. The Si-DLC-polished and the nitrided-draw showed more soldering in the 5215 core pin than in the 5205, the opposite happened for the AlCrN/TiCN. In general, the polished condition resulted in less soldering than in those with draw finish, what is in agreement with the qualitative results from the grading performed by Stellantis personnel. **Figure 37.6** compares the quantitative soldering results with the qualitative grade provided by Stellantis

Figure 37.5: Average soldering on core pins 5205 and 5215 comparing different coatings performance.

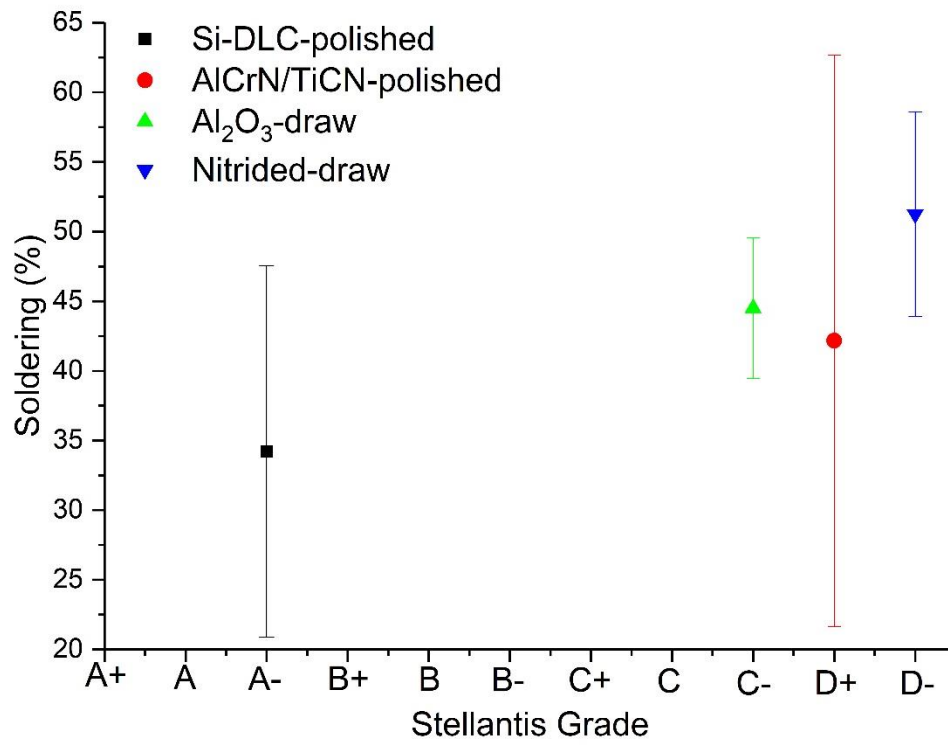
personnel, and some agreement in the tendency on the plot could be found. Visual inspection is a qualitative method where results close to the average can be inspected, the discrepancy here was in attributing a better grade to Al₂O₃-draw than for the AlCrN/TiCN-polished, what is also understandable due to big spread on the AlCrN/TiCN results.

Figure 37.6: Correlation between the Stellantis grade (qualitative) and the measured soldering (quantitative) for different coatings performance.

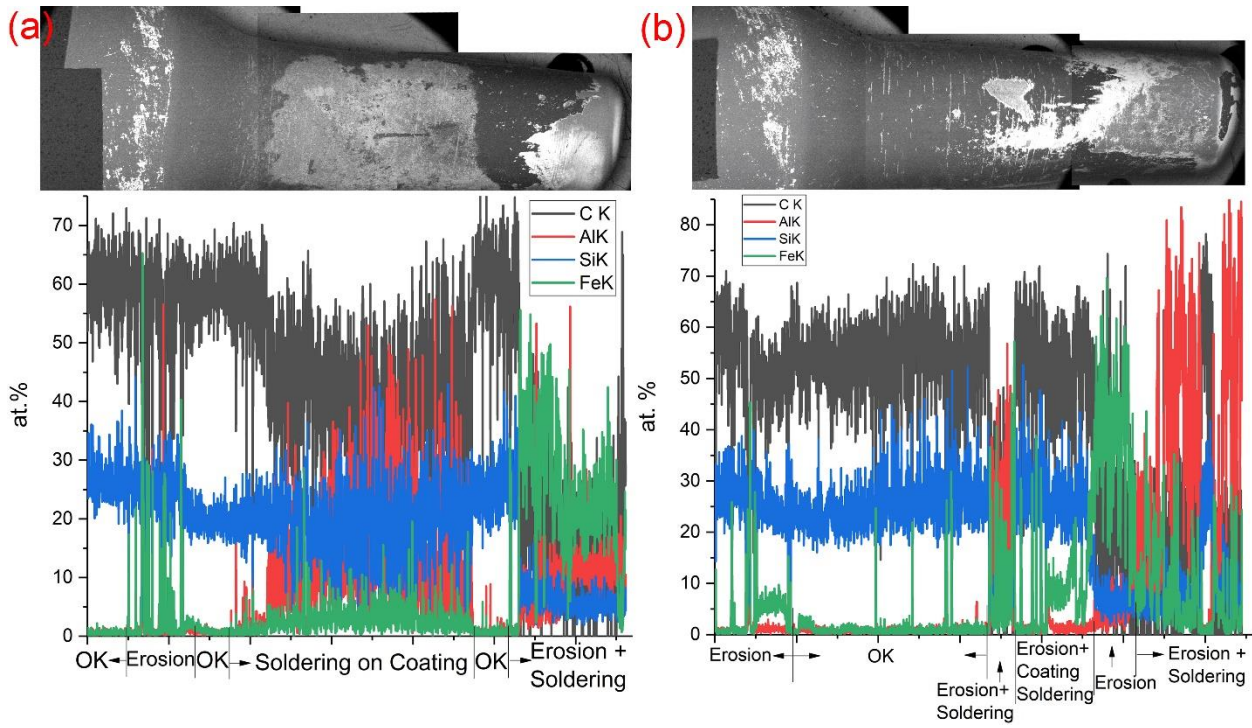
SEM analysis was performed for the surface of the core pin 5215 after the trials. **Figure 37.7(a)** shows an SEM BSE image for the Si-DLC-polished GS and **Figure 37.7(b)** for the OP, on the length of the core pin along with the EDS line scans. The combination of the BSE image and the EDS line scan and presented, and below is shown the proposed primary mechanism(s) of interaction at each position of the core pin along its length. As presented for the GS on **Figure 37.7(a)**, from left to right, the bigger diameter starts with a region where the coating is still pristine (OK), then it enters a region where coating erosion is the main mechanism (Erosion), and in the transition from the bigger to the smaller diameter the coating is conserved (OK). A huge portion of the center length of the core pin is covered with aluminum soldering, but also there is still coating on those areas with minor erosion (Soldering on Coating), then it enters into another region where the coating is preserved (OK). Close to the tip of the core pin it can be seen that erosion dominates combined with some minor soldering (Erosion + Soldering). At this point, most of the coating has been removed from the surface of the core pin. A very similar behavior can be seen for the OP side of the core pin, the main differences being the length along which each mechanism occurs. From left to right, the first region exhibits erosion, followed by a long length where the coating was preserved with minor erosion marks. As we move to the right, the differences are bigger, where there are changing mechanisms over small areas: first, soldering is observed on an eroded area where the coating has been removed (Erosion + Soldering) then, an area where some erosion happened but there is also soldering to the coating (Erosion + Coating Soldering), and finally followed by another area where the coating has been totally removed (Erosion). Closer to the tip of core pin it is similar to what was observed for GS: the coating has been removed by erosion and soldering happened, but it seems that more soldering has happened on this position for OP than for GS, and these differences are likely due to the GS being influenced by fast filling molten aluminum eroding the coating and also removing the soldering layers previously formed, while the OP side may be suffering from soldering and also dragging, or sheared lips, as previously proposed by Chen [37.9].

Figure 37.7: Back-scattered electron SEM image with EDS line scan of the Si-DLC-polished 5215 core pins, (a) GS and (b) OP side.

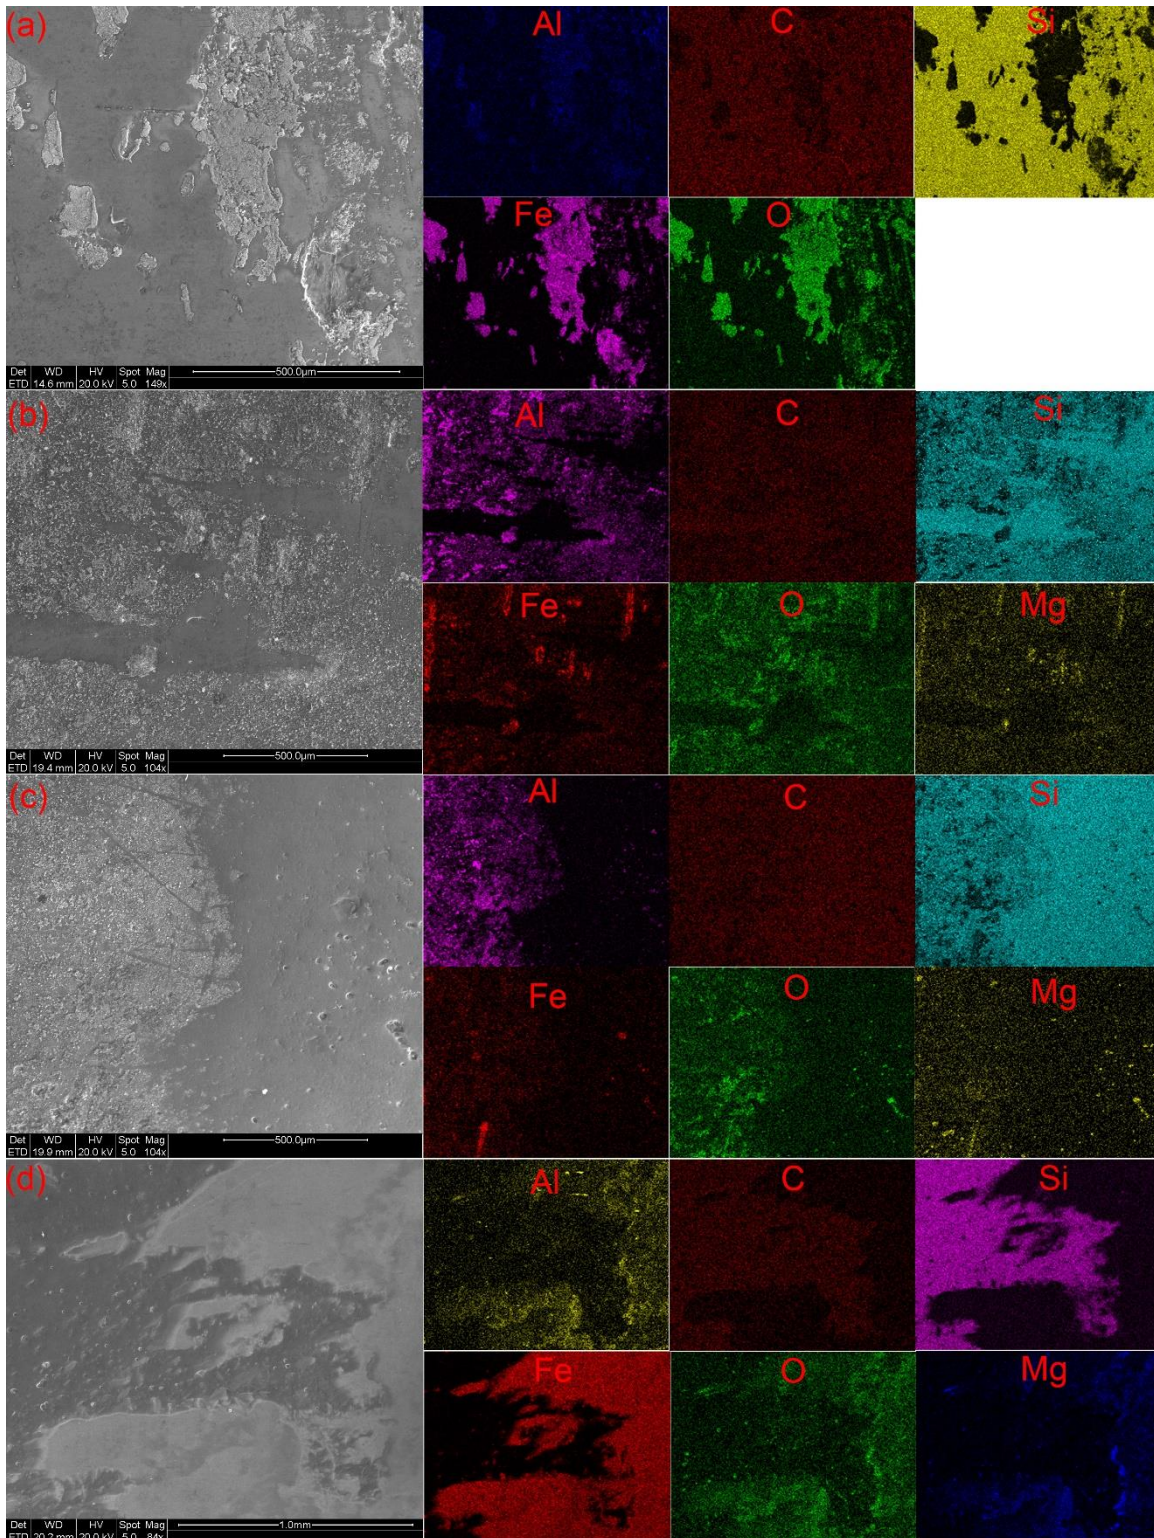
Figure 37.8 and **Figure 37.9** show more detailed analysis of each different mechanism for the Si-DLC-polished core pin GS and OP, respectively. **Figure 37.8(a)** and **Figure 37.9(a)** shows the region of the bigger diameter of the core pin where erosion was the main mechanism, as can be seen by the EDS map for Fe. The same eroded regions suffered with limited soldering as shown in the map for Al. **Figure 37.8(b)** shows the region of “soldering on coating” where a lot of Al can be seen in the EDS maps, but the coating is still present underneath the soldered layer as evidenced by the Si and C maps. Also, these results were combined with minor erosion indicated by the Fe maps, which could indicate the positions where the aluminum soldering occurred underneath the steel [37.10]. Interesting to note that in these same regions, a concentration of Mg and O can also be found, which suggests that Mg from the A380 alloy may be assisting coating oxidation and creating an easy path to the substrate, and similar results have been reported previously [37.11]. **Figure 37.8(c)** shows the transition from the soldered region in **Figure 37.8(b)** to the region where the coating was preserved (OK), some very limited erosion (Fe map), and some superficial rounded particles containing Mg and O found on the non-soldered side (right), which again suggests some influence Mg on this coating failure [37.11]. **Figure 37.8(d)** shows a region from the transition where the coating was preserved up to closer to the tip of the core pin where erosion + soldering prevailed, as can be seen in the EDS maps for Fe and Al in the right side without indication of coating elements (Si and C) present in that region. **Figure 37.9(b)** shows a coated region (OK) with very minor soldering (Al map) and minor erosion (Fe map) indicating a good preservation of the coating in those regions. **Figure 37.9(c)** shows an area with erosion and soldering happening on the same area as can be seen by the overlap of Fe and Al maps and Si and C absent from those regions. The Fe map also shows areas surrounding the soldered Al area. Interesting on this region is that the Mg and O maps lay exactly on the Al soldering map, and inside the area where the Al is lacking, the Mg is more concentrated. Since it is A380 alloy, the presence of Si particles would be expected on the soldered region but that is not observe in the EDS maps, which means that the soldering may be happening by the shear fracture of the casting soldered to the surface during ejection as proposed by Chen [37.9]. Finally, **Figure 37.9(d)** shows the erosion + soldering up to the rounded tip of the core pin. In the rounded region, the Si and C EDS maps show that the coating is still present there, surrounded by the Fe map indicating coating erosion, also the Mg and O maps surround the coated region and the eroded region, again indicating that the Mg from the A380 alloy may be the key element on the oxidation and failure of the Si-DLC coating, probably through oxidation as the O map follows the Mg maps [37.11].

Figure 37.8: Secondary electron SEM image with EDS maps of Si-DLC-polished GS 5215 core pins for the different failure mechanisms, (a) erosion with minor soldering, (b) soldering on coating with minor erosion, (c) transition from soldering on coating to a coated region, and (d) erosion + soldering.

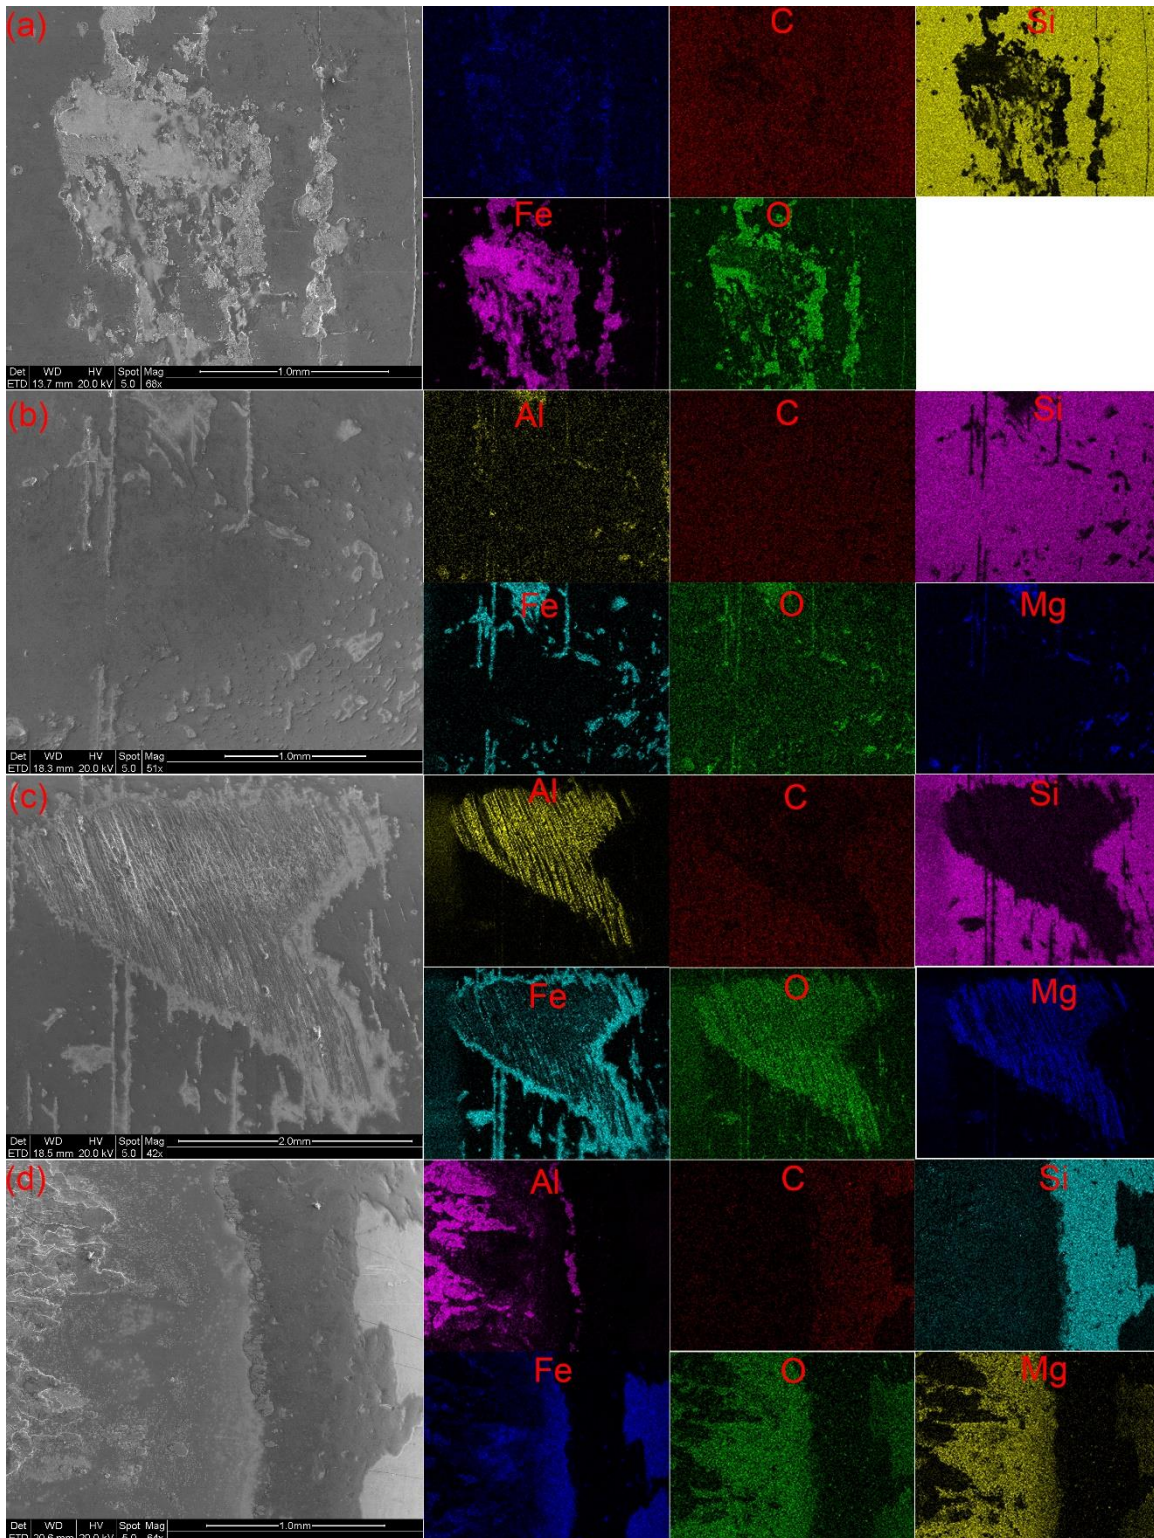
Figure 37.9: Secondary electron SEM image with EDS maps for Si-DLC-polished OP 5215 core pins for the different failure mechanisms, (a) erosion with minor soldering, (b) coated region (OK) with very minor soldering and minor erosion, (c) erosion and soldering, and (d) erosion + soldering up to the tip of the core pin.
